The Restoration of the Athenian Acropolis

by Dr. Fani Mallouchou-Tufano

Lecture delivered on 1/18/2006

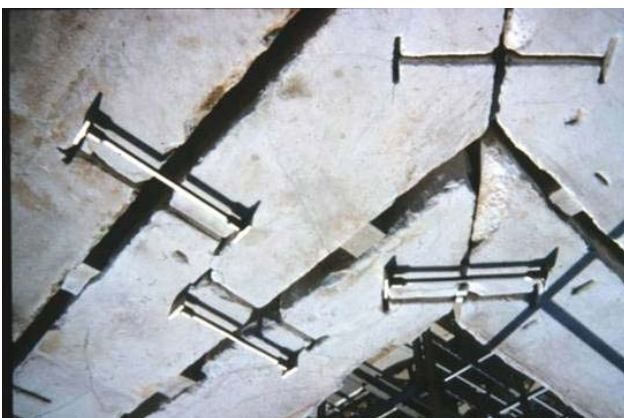
The works consist of interventions aiming at the structural restoration of the individual architectural members or of larger sections of the monuments as well as of those concerning the conservation of the monuments surface. During the interventions the parts of the monuments that had been restored in the past – and in those, which had been left untouched, but which have significant preservation problems, are dismantled. The articulated system of construction, characteristic of greek classical monuments, greatly facilitates this sort of work. For they are made up of independent architectural members in dry assembly, with iron clamps and dowels, without the use of mortars. The dismantled pieces undergo conservation; the rusted metal reinforcements are removed and replaced by others of titanium, the broken pieces are rejoined with titanium reinforcing and a special cement based mortar.

This was the first time that titanium has ever been used in monumental restoration, based on late Prof. Theodore Skoulikides research. Titanium was chosen because it is stable even in aggressive environment such as the maritime one of Athens. Also because it is compatible, in its mechanical properties, with the pentelic marble of the monuments (the same coefficient of expansion-contraction). Where considered necessary, missing parts of the architectural members are infilled with new Pentelic marble so as to restore their original structural

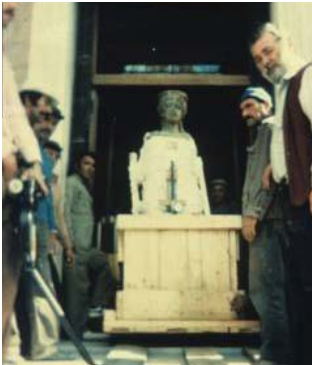
efficiency. The new infills are made using sculptural pointing devices to match exactly the fragmented surface of the ancient block. This reduces further deterioration of the ancient member and guarantees the reversibility of the operation (reversibility is one of the main theoretical principles of the project): eventually if an ancient fragment is found it can be re-integrated in its correct place in the building fabric.

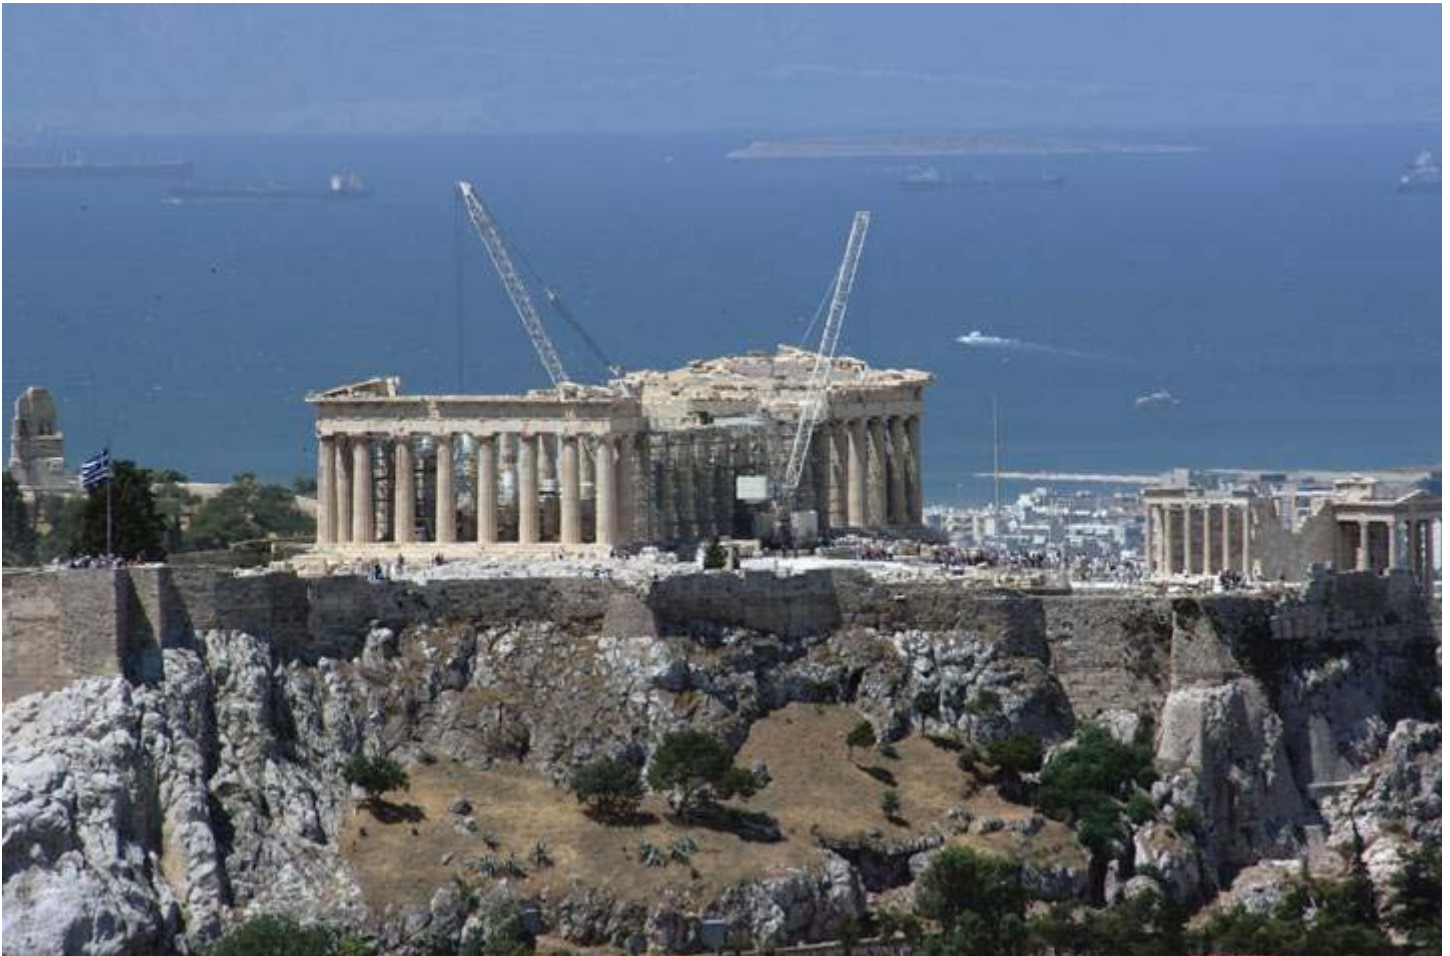
The Parthenon restoration project is divided into twelve piecemeal programmes involving the various parts of the monument, the four sides of the exterior colonnade, the walls of the sekos (the temple's interior), the pronaos and the opisthonaos (the front and the rear interior porches), the steps (crepidomata) and floor surfaces of the temple. In charge of the intervention on the Parthenon is the architect Nikos Toganides. The intervention on the monument began from the east façade, which had been seriously damaged during the earthquake of 1981 and which has been restored from 1986 until 1991. Work began with the dismantling of the remaining segments of the pediment and

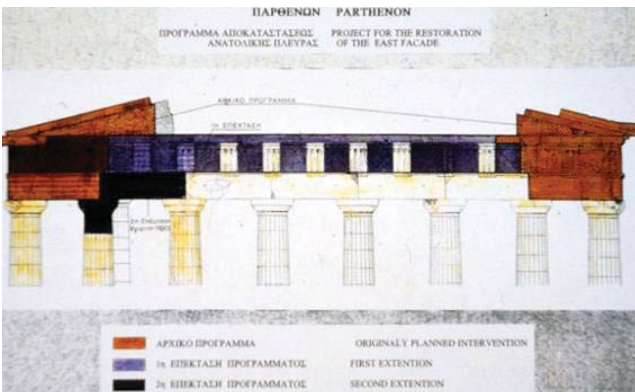
the entablature at the corners of the façade (the parts coloured in orange) and proceeded with the dismantling of all the cornices, in order to remove the 14 metopes along with the three most eastern of the north side to the museum, and to repair the upper drum of the 7th (from the north) column (the parts coloured in blue and black). The extension of the initial programme was made necessary by the state of preservation – much worse of that expected – of the ancient parts constated after the dismantling of the two corners of the façade)..

The dismantled architectural members were replaced on the monument after conservation. On the monument copies of the metopes in artificial stone and the remaining pedimental statues have been placed. At the end of the work the precise geometrical form of the Parthenon east façade, disturbed in the past by earthquakes and the explosion of 1687, had been restored.

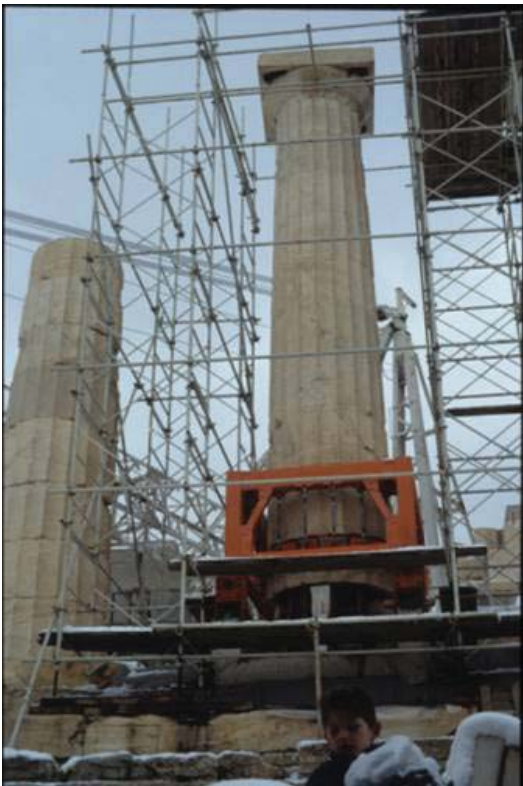
In the Parthenon in the parts preserved *in situ* since antiquity, the structural accuracy is amazing, and the contact and adhesion of the architectural members, what ancient Greeks called *harmonia*, is nearly perfect. For this reason particular effort is made in order to respect the structural authenticity of the building and to avoid disturbing it during the operations. Special devices are designed and original ways are invented for the intervention on parts of the building never dismantled in the past. Such an intervention was realized in 1992, the restoration of the fifth (from the east) column on the South colonnade of the Parthenon. The column had suffered a displacement from the second drum and above during the explosion of 1687. A third of the first drum had been destroyed and the equilibrium of the area was extremely precarious, in particular after the quake of 1981. In order to solve this problem the entablature was dismantled and the entire column, which had also shifted during the explosion, was clamped, lifted, turned and moved almost three metres towards the interior of the temple, by means of a patent system, designed by the architect Manolis Korres. The first drum was filled with

new marble, the bedding surfaces of which were leveled off with extreme accuracy. The column was then restored to its original verticality and placed back on its now restored base drum. It should be noted that the entire column, weighing about 60 t. was lifted by using purely frictional forces and not by the more common methods of hoisting.

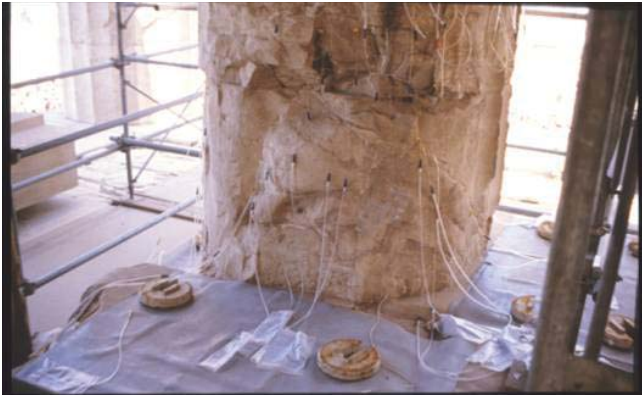
In 1997-1999 the columns of the opisthonaos (the west inner porch of the Parthenon), which had suffered extensive fire damage and presented large interior voids, had been consolidated by grouting in their interior a hydraulic mortar (cement, lime and hydraulic additives) and by implanting titanium reinforcements (*the columns had never been dismantled in the past, so this method of consolidation had been chosen, in order to avoid dismantling them and harming the preserved harmony*). The

last summer, included also the dismantling, the structural restoration and the resetting in their original position of all the parts of the porch previously restored or preserved in situ (for ex. all the architrave blocks of the colonnade, the columns capitals, the crown capital of the NW anta, the crown blocks and the backers of the West frieze) as well as the making and the repositioning on the monument of cast reproductions of the west frieze. This intervention has been carried out in accordance with studies by the architects Petros Koufopoulos and Rosalia Christodouloupoulou.

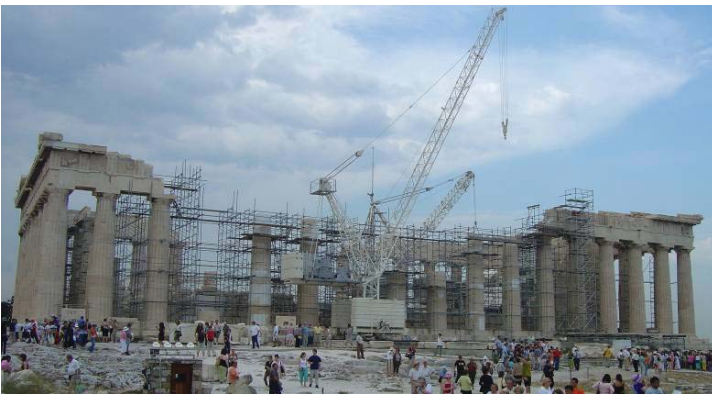
The programme for the North colonnade central zone includes the dismantling and restoration of the entablature and the eight columns that had been restored by Balanos in the 1930s. The rusted metal clamps and dowels are to be removed, new marble is to replace the cement fillings of the previous intervention, and the architectural members, especially the drums, are to be restored to their original positions, in accordance to established methodology. The intervention is scheduled

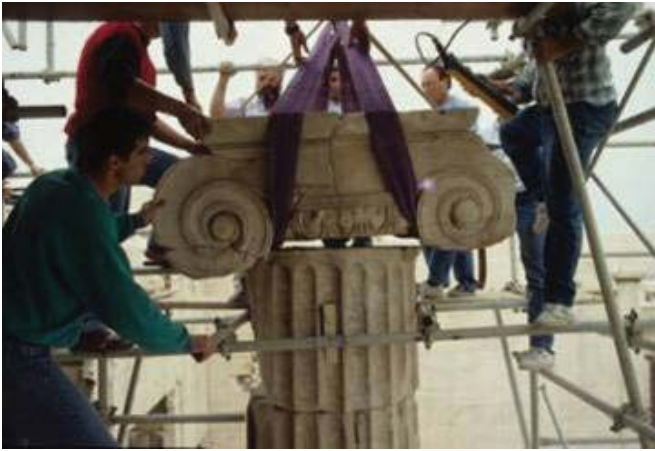
In the Propylaea the restored by Balanos coffered ceilings of the central building have been dismantled . The heavy iron rods and the coarse cement joints of earlier restoration have been removed from the large marble beams of the ceilings. At the same time efforts have been made to discover the original position of the ceiling coffers and, in particular, to identify the hundreds of fragments which had been left on the ground during the previous intervention. These efforts have been very successful since they resulted in the identification of the totality of the scattered fragments, offering thus a much larger

quantity of ancient material available to be placed back in its original position. In fact, the approved study for the restoration of the ceiling by the civil engineer Maria Ioannidou, who is also the director of the Acropolis Restoration Service, and of the architect Tasos Tanoulas, in charge of the Propylaea Restoration Project, proposes to extend the anastelosis beyond the boundary of Balanos' intervention.

Specifically the study proposes resetting in the ceiling of the East stoa seven beams, that is four more than those set by Balanos, and the coffer slabs of the first three (from the N.) inter-beam spaces (that is five more slabs than those used in the Balanos intervention). Proposed for the Western hall is the anastelosis of the coffers in the two inter-beam spaces of the NE corner of the ceiling, which had been restored earlier, but also in the two inter-beam spaces toward the S., above the central passageway of the monument (*this is an important intervention, because will change in the future the sensation of the approach of the Propylaea*

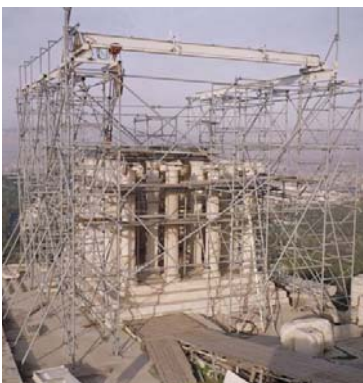
The temple of Athena Nike is under restoration for a third time. Works begun in 1998 with the removal of the frieze to the Acropolis Museum. On the monument will be replaced by artificial stone casts. The project includes the dismantling, restoration

and reassembling of the some 300 architectural members of the monument following the study of the architects Demosthenes Giraud and Kostas Mamaloungas. After the complete dismantling of the temple came to light again the small earlier classical temple, beneath the later one. The project includes also the replacement of the slab of reinforced concrete (of the Balanos restoration) that covered the entire floor on the cella of the temple with a stainless steel grid. The completion of this intervention is scheduled also for the end of 2006.
